DEPARTMENT OF TRANSPORTATION

Quality Assurance and Source Inspection

Contract #: 04-0120F4Cty: SF/ALA Rte: 80 PM: 13.2/13.9File #: 69.15**SOURCE INSPECTION REPORT****Resident Engineer:**Siegenthaler, Peter**Address:** 333 Burma Road**City:** Oakland, CA 94607**Report No:** SIR-003522**Date Inspected:** 15-Jul-2011**Project Name:** SAS Superstructure**OSM Arrival Time:** 700**Prime Contractor:** American Bridge/Fluor Enterprises, a JV**OSM Departure Time:** 1900**Contractor:** Zhenhua Port Machinery Company, Ltd (ZPMC), Changxing Island **Location:** Shanghai, China**Quality Control Contact:** Don Walton**Quality Control Present:** Yes No**Material transfer:** Yes No N/A**Sampled Items:** Yes No N/A**Stock Transfer:** Yes No N/A**OK to Cut:** Yes No N/A**Rebar Test Witness:** Yes No N/A**Delayed/Cancelled:** Yes No N/A**Other:****Bridge No:** 34-0006**Component:** OBG Component**Bid Item:****Lot No:** B278**Summary of Items Observed:**

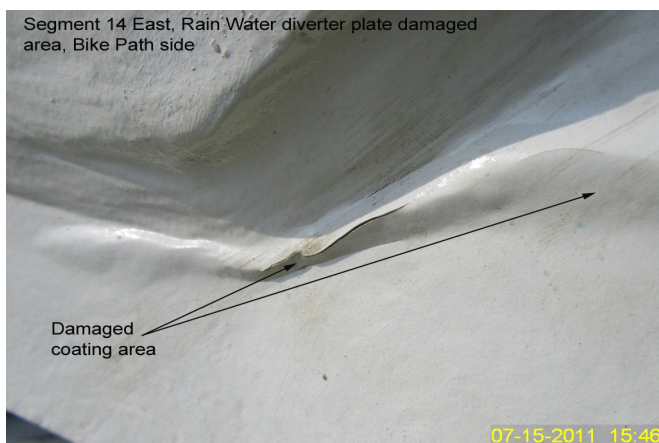
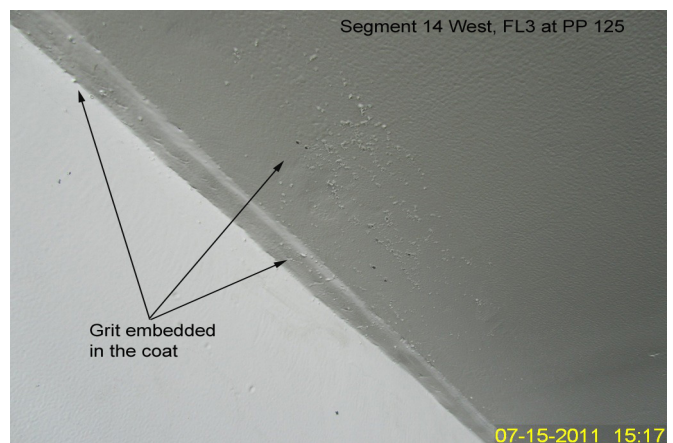
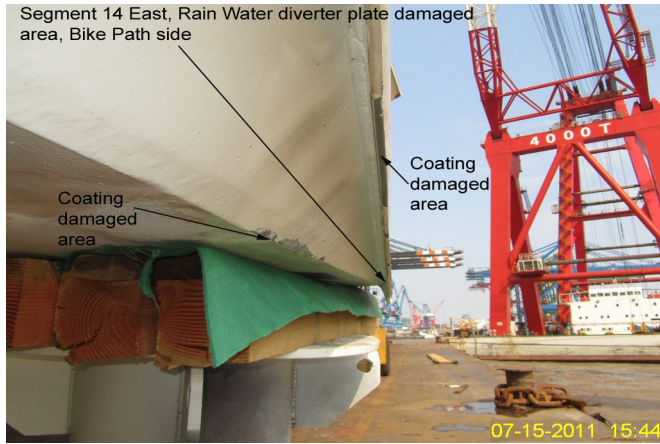
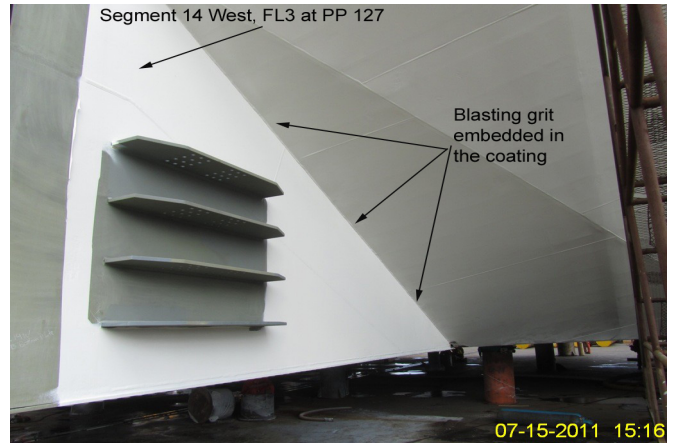
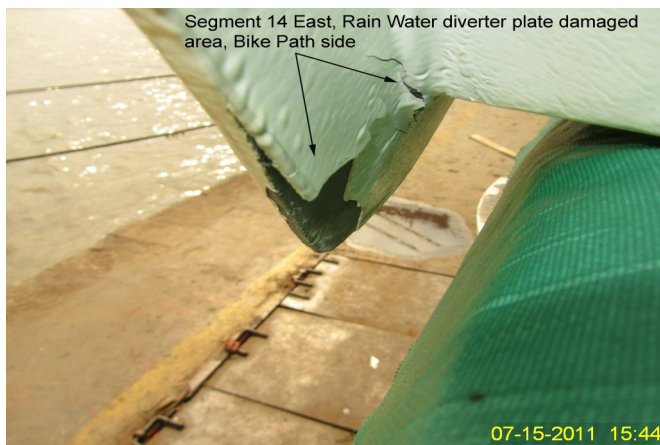
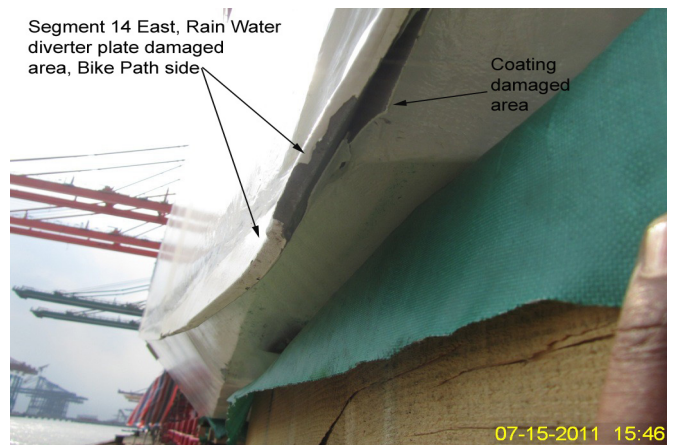
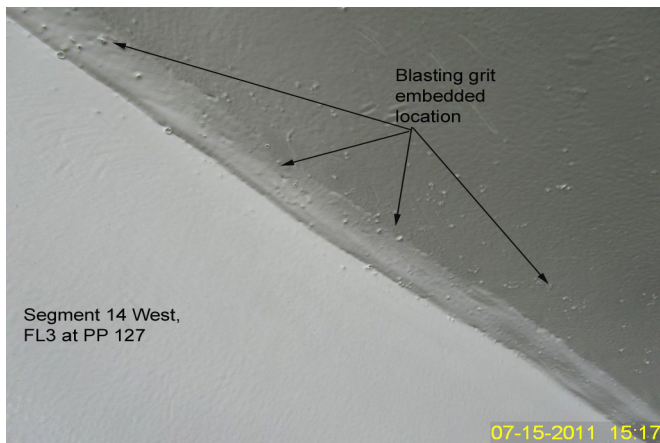
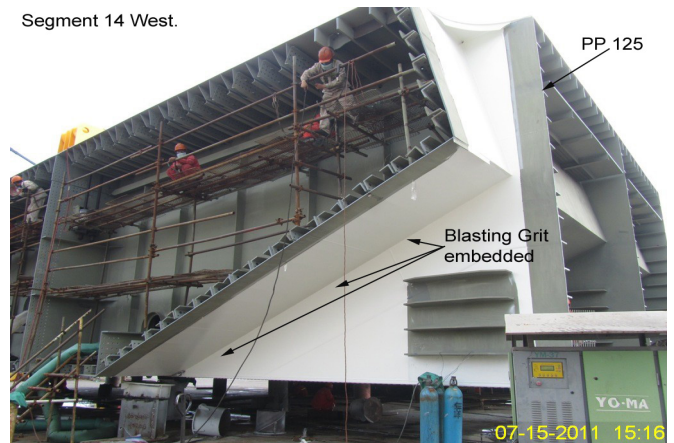
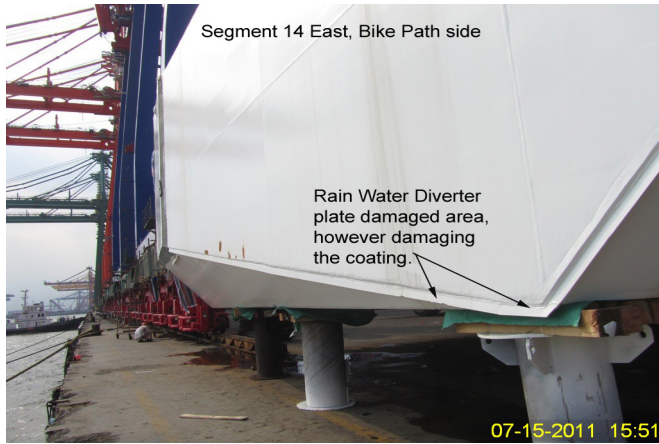
Inspection Conclusions: Rejected by ABF QA as few locations needs touch painting, grit removal from the paint embedded areas to be removed and Caltrans QA concurred with the ABF QA's Inspection.

Inspection Conclusions: Rejected Lift 14 East, External Surface by ABF QA as few locations needs touch painting, grit removal from the paint embedded areas to be removed, Drip Plate(Rain Diverter Plate) is damaged during handling and got distorted and Accepted Lift 14 East, Internal Concrete embedded area and the Caltrans QA concurred with the ABF QA's Inspection.
